Manhole Inspection Summary

Manhole # S63G__015MH

Insp Date: **5/14/08 10:40 AM**

Location Address: **Alley behind 431 Anglesea St.**

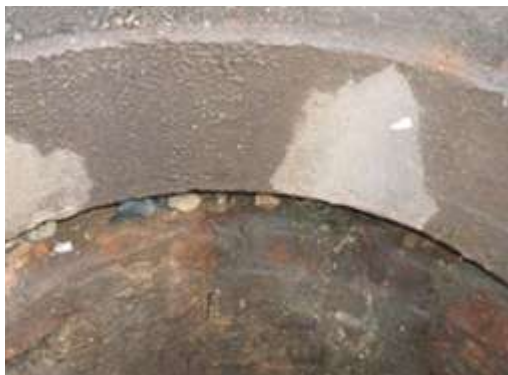
Defect 2

infiltration

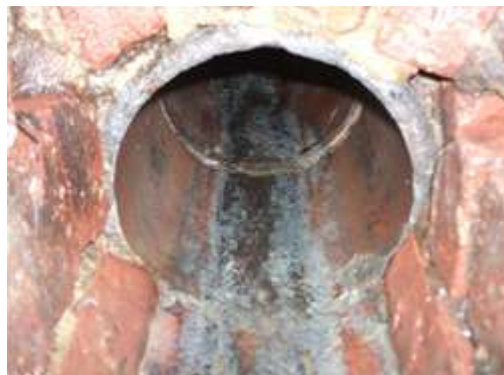
Defect 6

Crack in pipe seal. Missing mortar 2:00 on outgoing 12 o'clock

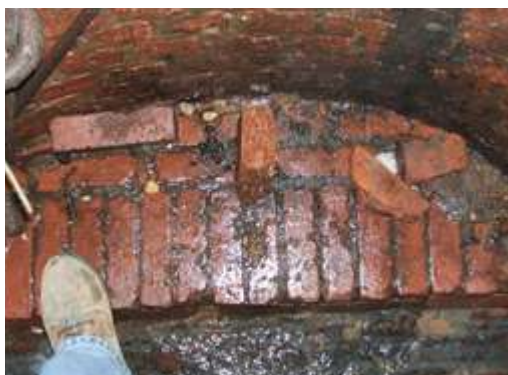
Defect 4

debris on bench

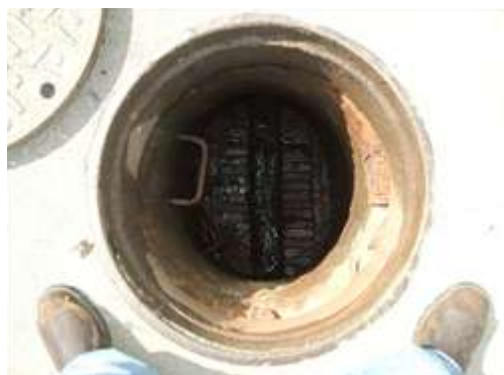
Defect 7

Frame offset

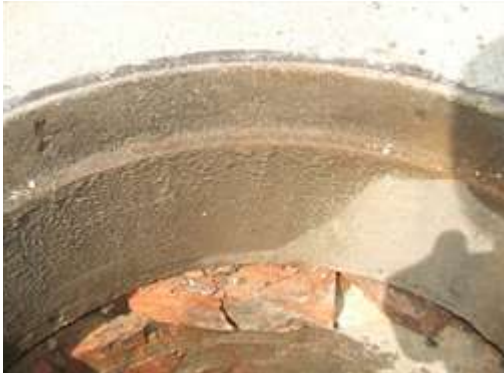
Defect 1

Condition: ☐ Sound ☐ Cracked ☐ Root Intrusion ☒ **Loose Brick** ☒ **Deteriorated**

loose bricks at frame adjustment

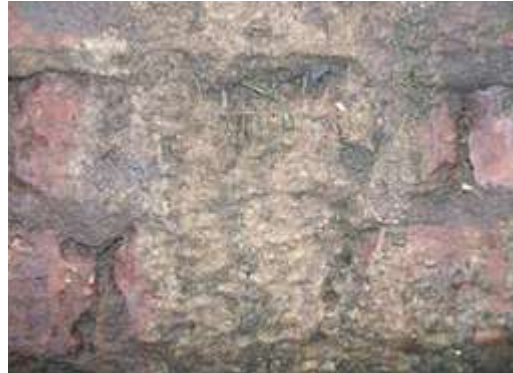
Defect 5

infiltration

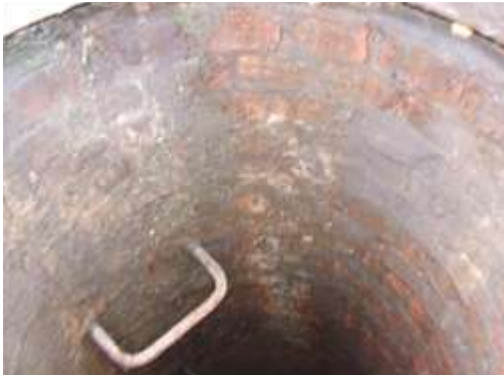
Defect 3

infiltration

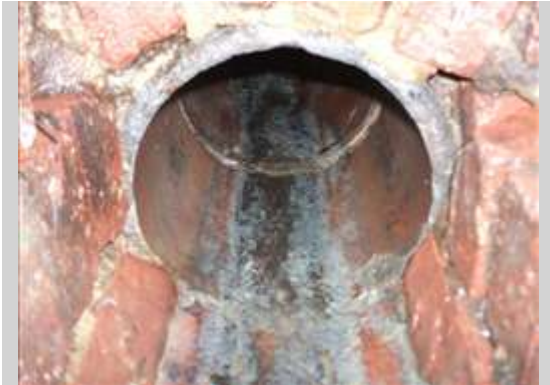
12 O'Clock Outflow

Infiltration: **None** Pipe Seal Cond: **Cracked**
